## Oilfield Startup Acceptance & Reliability Program Monitors Reciprocating Compressors

Oilfield by-product gas compression and redistribution.

# NATURAL GAS PROCESSING

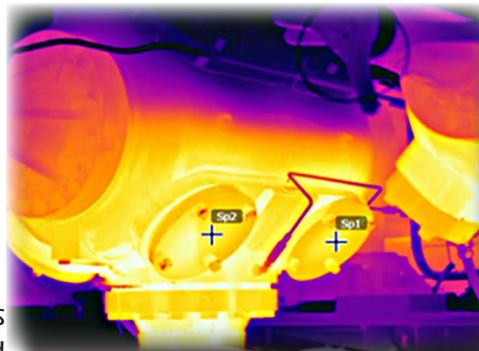
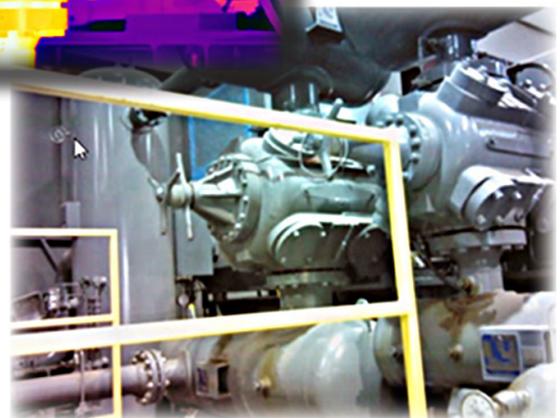
*Infrared image (at left) of selected area of compressor component (at center below) reveals areas of high temperature, friction, or wear issues and potential for malfunction leading to unplanned downtime or catastrophic system failure.*

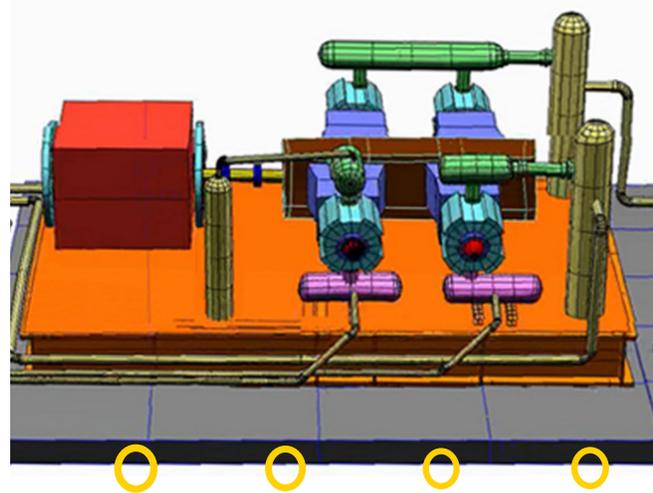
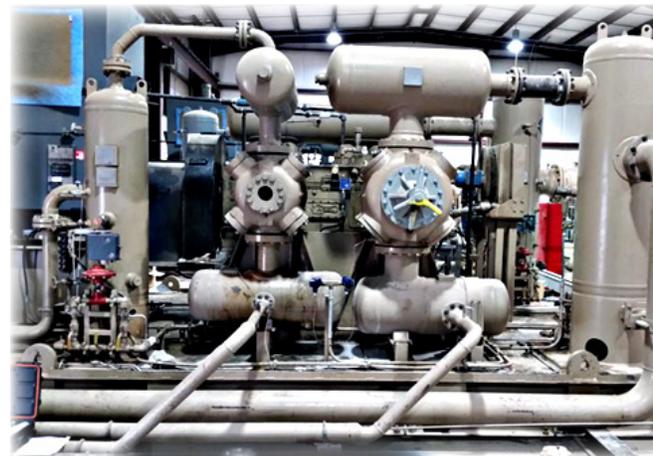
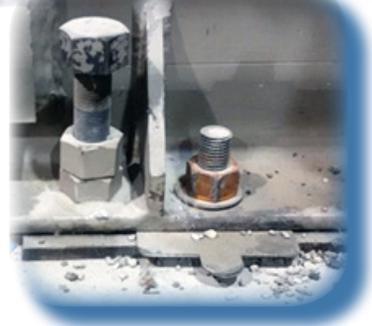
Initially, during the acceptance phase, on one compressor unit, the Novaspect team used advanced diagnostics including **operating deflection shape (ODS) analysis**. This vibration test discovered significant negative structural anomalies that were traced to improperly installed external shims on the compressor skid. Immediate corrective action was recommended to avoid catastrophic failure.

CAD drawing of the compressor unit (shown above; photo below) shows individual components that were modeled using the operating deflection shape (ODS) analysis. In the course of testing, the analysis determined that metal shims (located at yellow circles; detail photo shown far below) were added to the base of the unit with center beams of the structure left unsupported. This negatively affected the vibration and stability of the entire system. The corrective remedy required lifting the unit and jack-hammering out the concrete base.
